Advanced Technology Composite Fuselage—Materials and Processes

The Boeing Company • Seattle, Washington

This document is one of nine complementary final technical reports on the development of advanced composite transport fuselage concepts. The work described was performed by the Boeing Commercial Airplane Group, Seattle, Washington, from May 1989 through December 1995 under contracts NAS1-18889 and NAS1-20013, Task 2. The contracts were sponsored by the National Aeronautics and Space Administration, Langley Research Center (NASA-LaRC) as part of the Advanced Composite Technology (ACT) program. Direction from NASA-LaRC was provided by M.J. Shuart, J.G. Davis, W.T. Freeman, and J.B. Nelson.

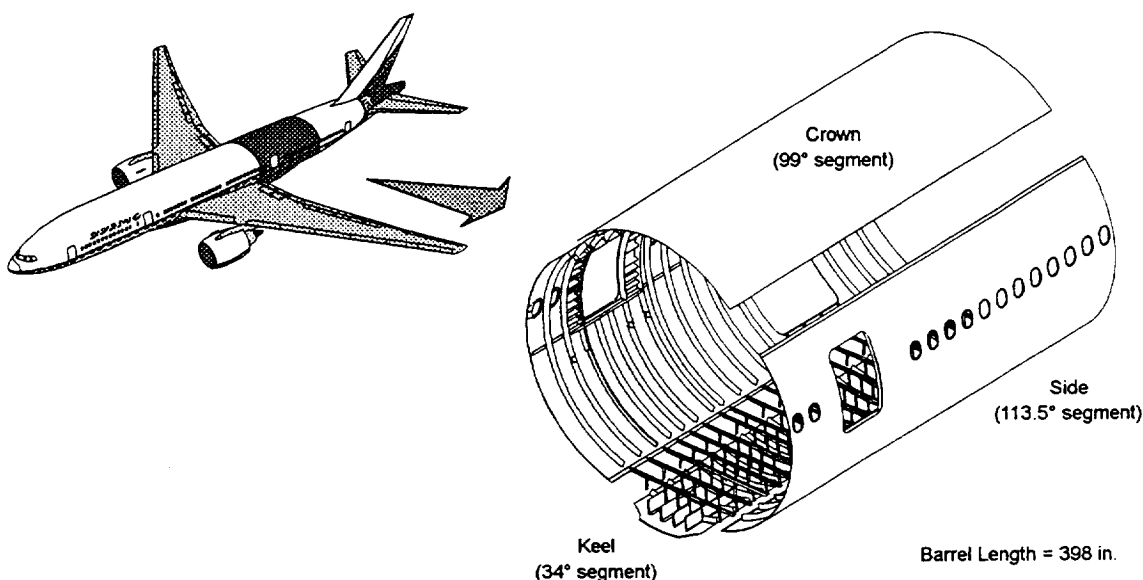
Figure 2-1. Baseline Vehicle and Study Section.

The fuselage section just aft of the wing-to-body intersection of a commercial wide body transport aircraft was chosen for study (Figure 2-1). This section contains many of the structural details found throughout the fuselage. The 'quadrant' configuration was adopted to minimize the number of longitudinal splices while maintaining design flexibility for regions with differing requirements [2, 3].

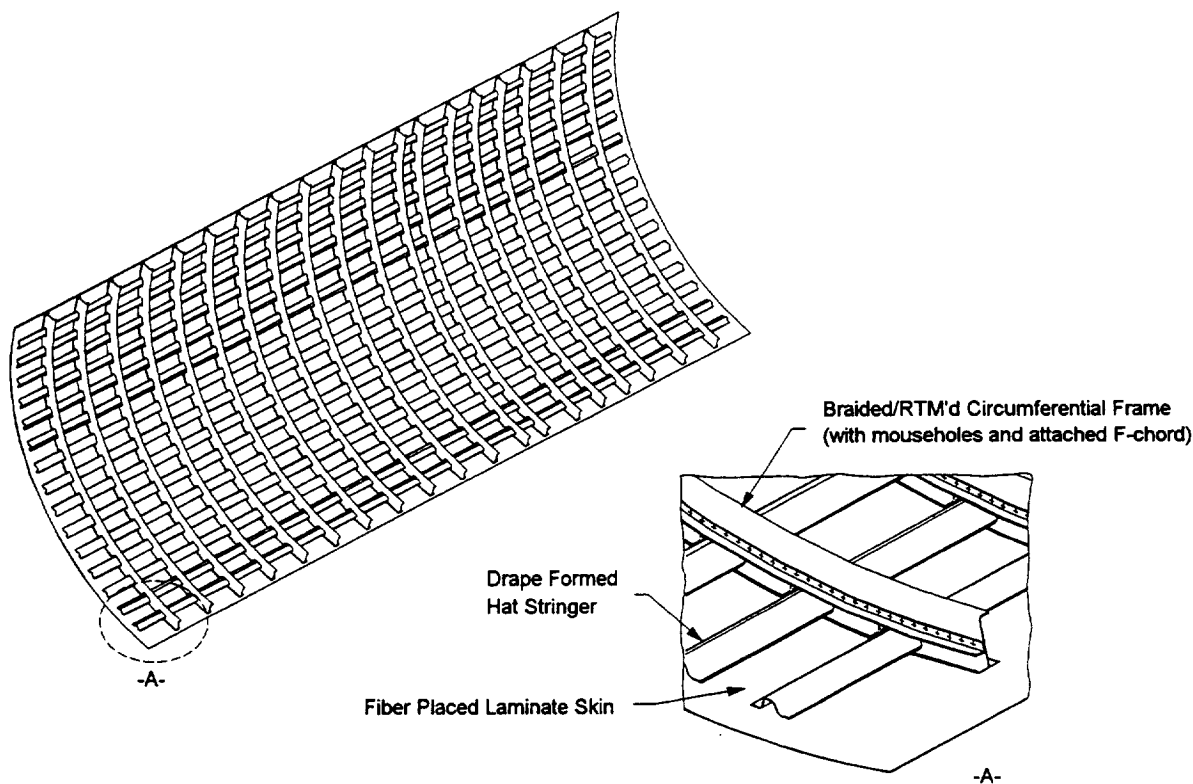
Figure 3-1. Baseline Crown Panel Design Concept.

The crown panel design concept chosen for local optimization is a stringer-stiffened skin configuration as illustrated in Figure 3-1 [2, 3]. The design features cocured longitudinal hat section stringers and cobonded J-section circumferential frames. Cut-outs in the frames allow continuous stringers, but necessitate the inclusion of fail-safe chords. No significant changes have been made to the baseline configuration during local optimization.

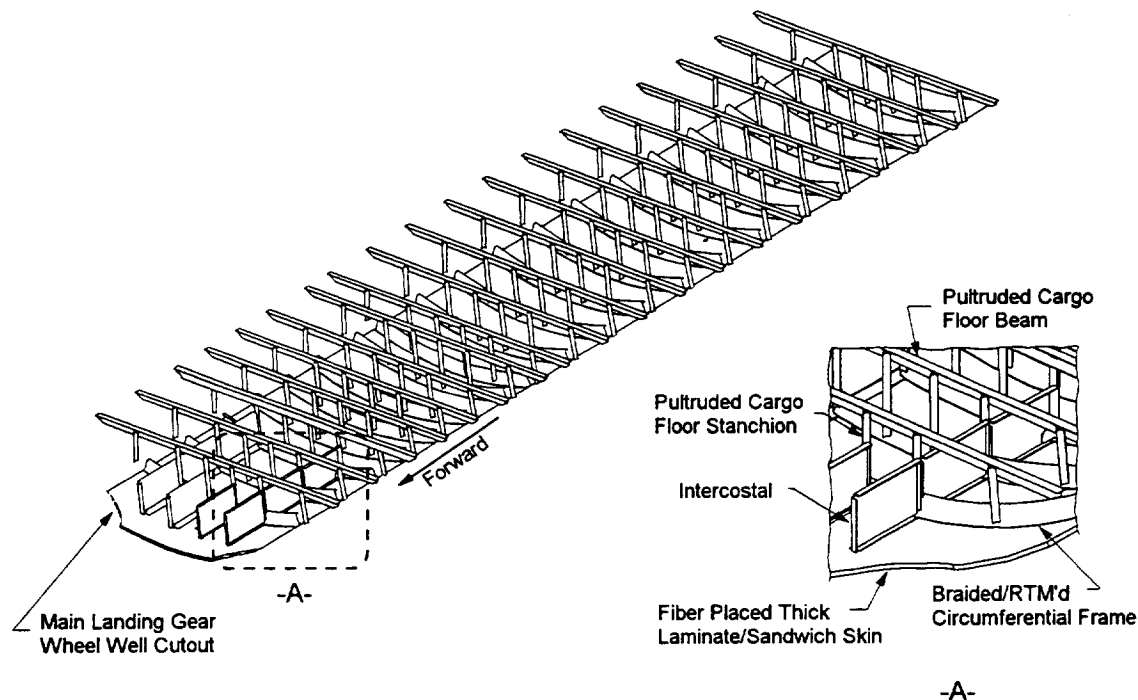
Figure 3-2. Baseline Keel Panel Design Concept.

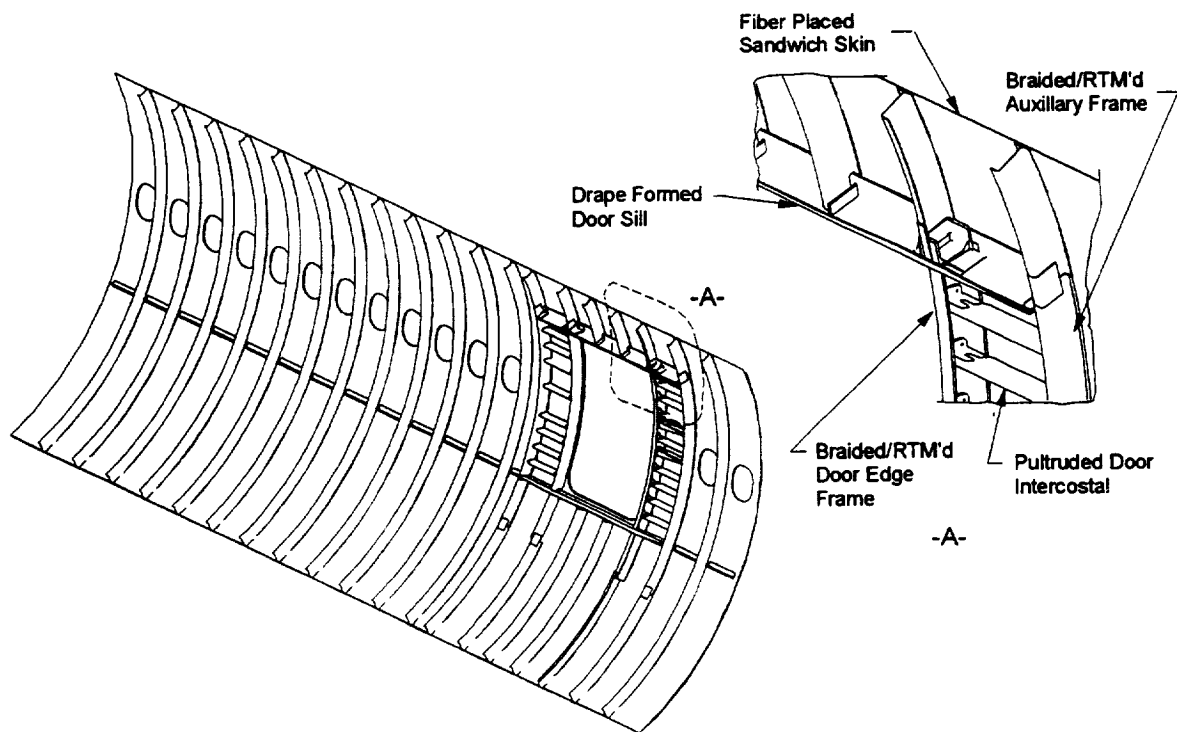
Figure 3-5. Baseline Side Panel Design Concept.

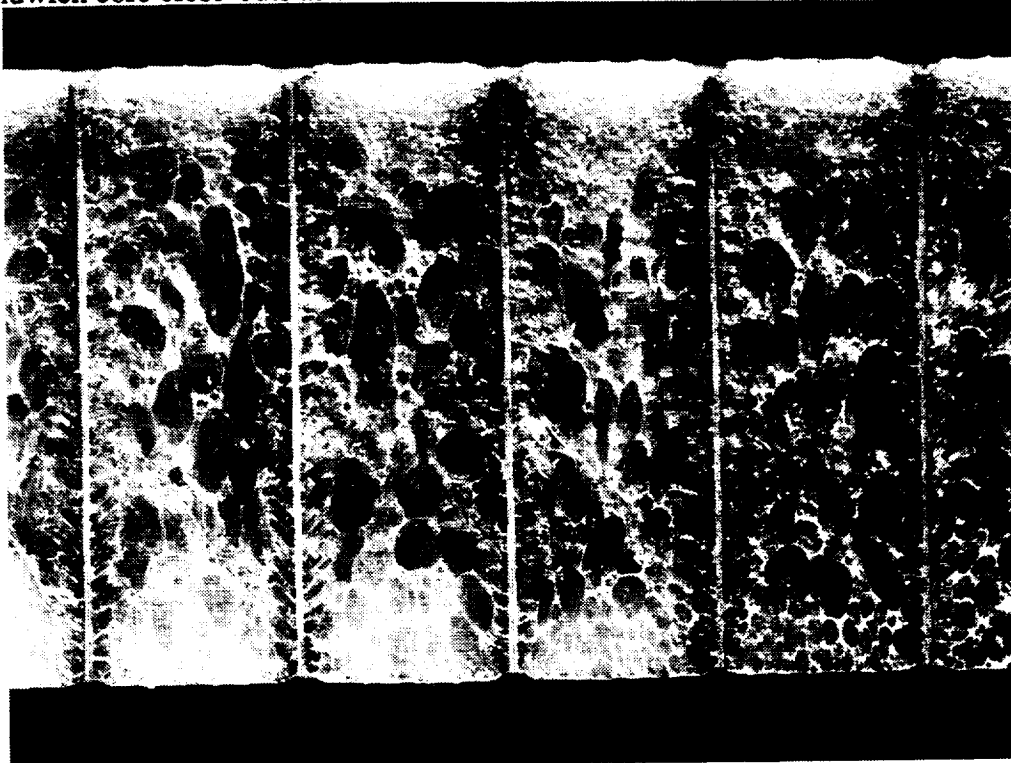
Figure 4-10. Foam-Filled Honeycomb Fabricated with Hexcel's Cyanate-Ester K Foam and HRH-10-1/8-5.0 Honeycomb.

Foam-filled honeycombs (Figure 4-10) were investigated for use as keel sandwich core materials in an effort to enhance impact damage resistance. A cyanate-ester foam developed by Hexcel was of particular interest because of its resistance to moisture sorption [19]. A manufacturing process development effort was initiated and sandwich panels with foam filled HRP and HRH-10 (Nomex) core materials were fabricated. This effort was curtailed due to poor performance in impact damage resistance surveys as discussed in Section 6.1.2. However, foam filled honeycombs were used in development of sandwich core close-outs as discussed in Sections 4.4.1 and 4.4.3.

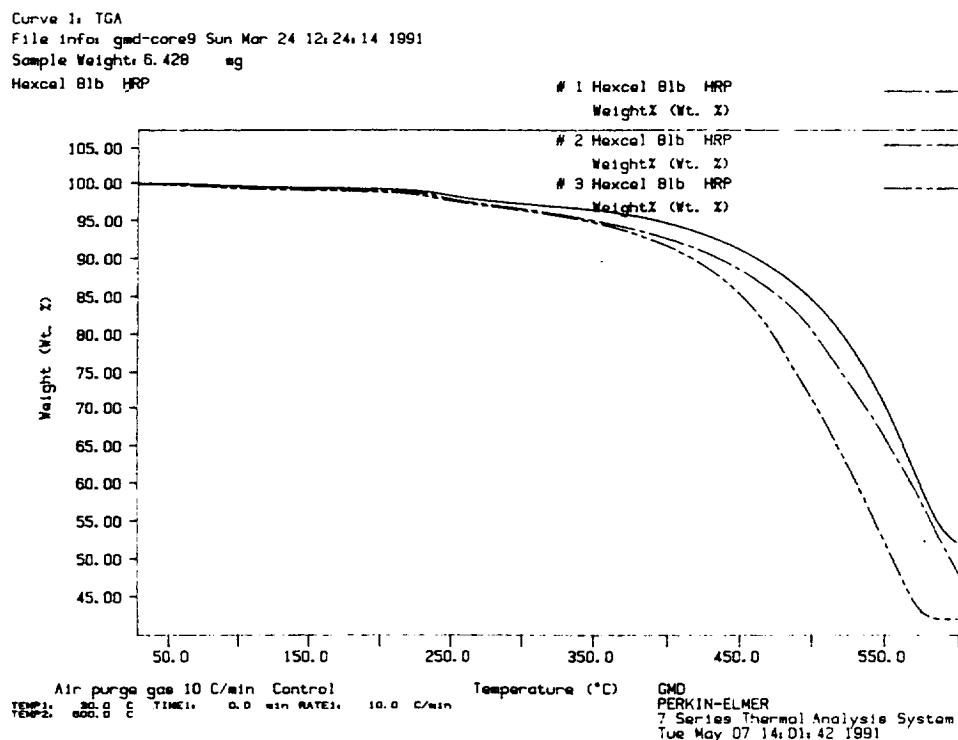
Figure 4-11. Thermogravimetric Analysis of Hexcel's HRP Honeycomb.

Thermogravimetric analysis (TGA) was used to identify temperatures at which oxidation and pyrolyzation may occur in the honeycomb and in the constituent materials. Weight loss was observed in three regimes (Figure 4-11) and was attributed to: volatilization of absorbed water, evolution of additional water as a byproduct of further polymerization, and thermal degradation of the phenolic matrix. The results indicate core forming operations should be conducted at temperatures below 500°F (260°C).

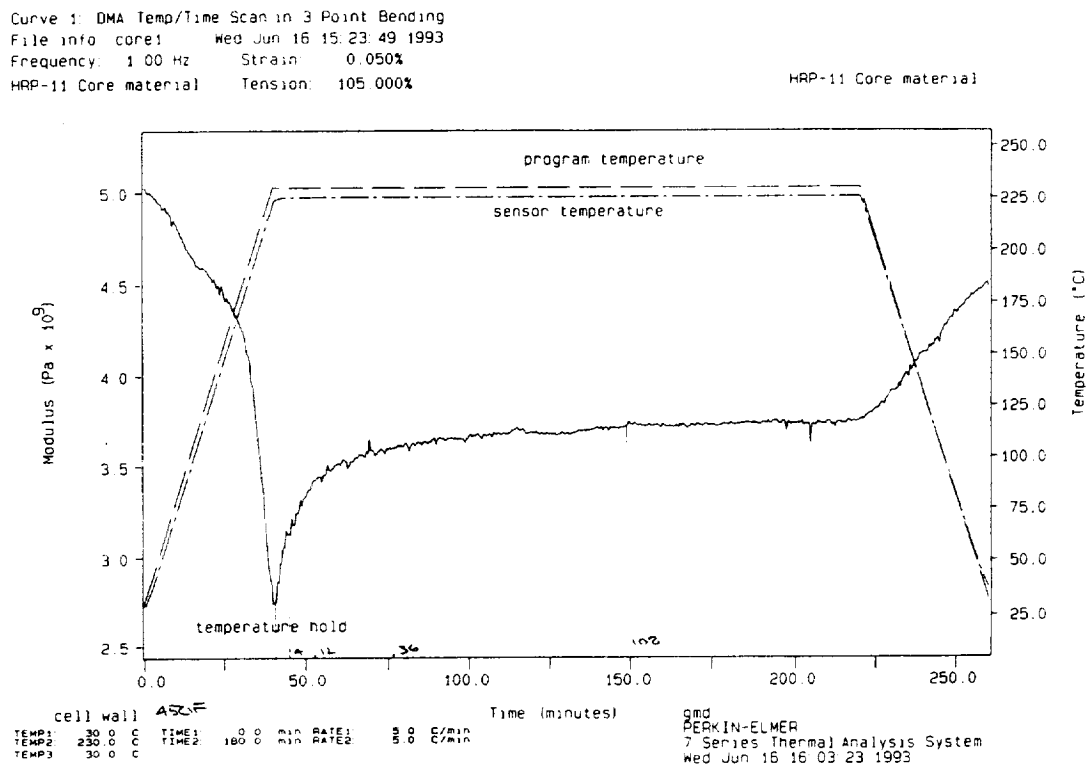
Figure 4-12. Dynamic Mechanical Analysis of Hexcel's HRP Honeycomb.

Dynamic mechanical analysis (DMA) was used to characterize the rate of polymerization at typical heat forming temperatures. The results of these tests were used to define thermal exposure times and temperatures for mechanical test panels (Figure 4-12).

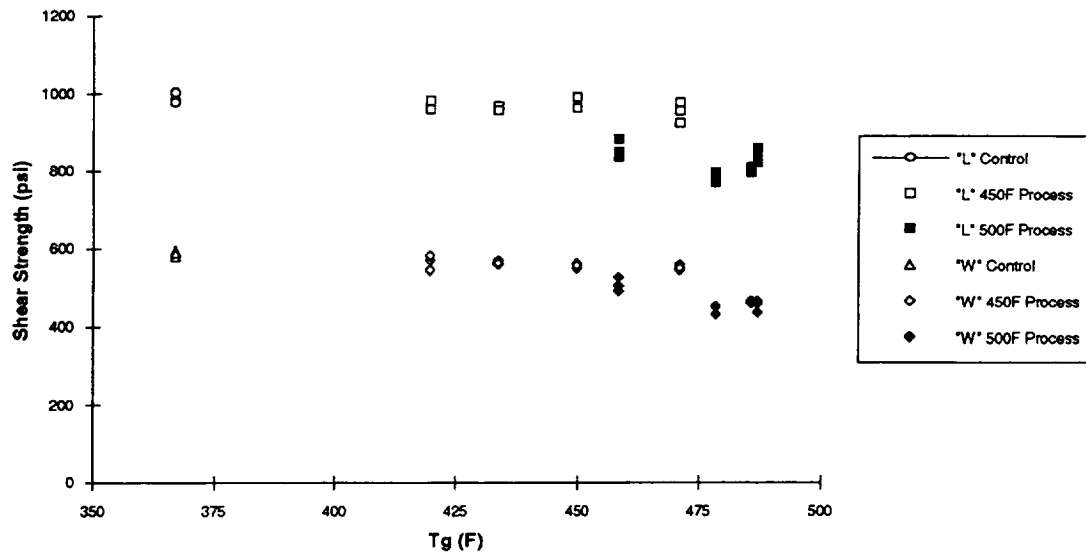
Figure 4-13. Through-Thickness Shear Strength of Hexcel's HRP Honeycomb Following Exposure to Elevated Temperatures. "L" and "W" Indicate Loading Parallel and Perpendicular to the Core Ribbon, Respectively.

Test panels representative of the aft keel sandwich structure were fabricated with honeycomb details which had been subjected to various thermal exposures. The sandwich structures were tested for core shear strength as well as impact damage resistance. Shear strength test results were correlated with T_g as an indication of the level of polymerization. The shear strength was reduced only slightly by processing at 450°F as shown in Figure 4-13. Processing at 500°F caused a greater reduction in shear strength.

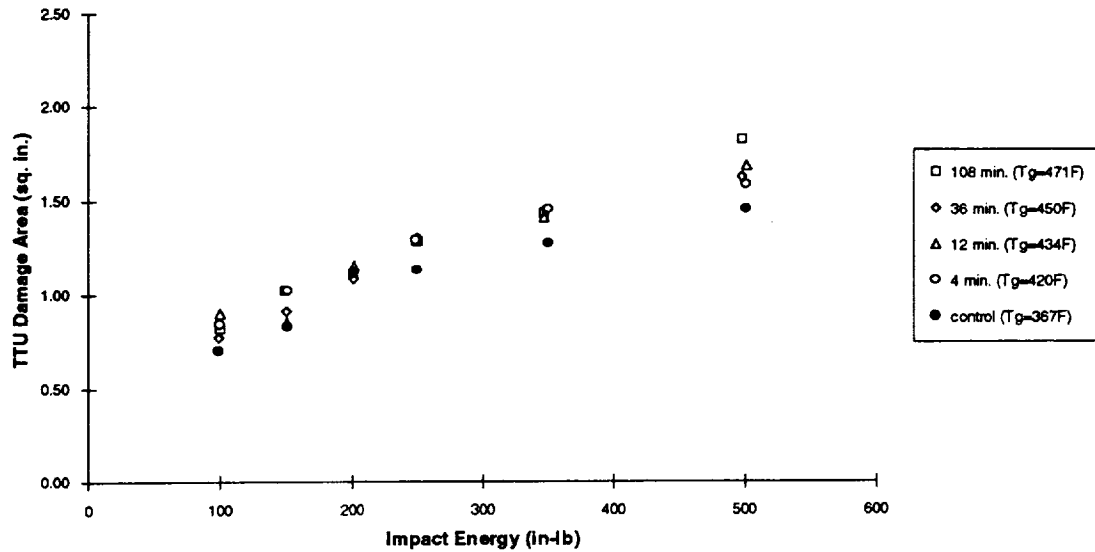
Figure 4-14. Impact Damage Resistance of Hexcel's HRP Honeycomb Following Exposure to 450°F.

Impact surveys were conducted to determine the effect of the thermal exposure on impact damage resistance. The panels were impacted at low velocity with a one inch diameter spherical steel tup at energy levels ranging from 100 to 500 inch-pounds. Through-transmission ultrasonic (TTU) inspection was used to determine the planar extent of impact damage. The reliability of TTU for detecting impact damage in sandwich structures was verified, as discussed in Section 6.1.2. Impact damage resistance was degraded only slightly for processing at 450°F and to a greater extent for processing at 500°F as shown in Figures 4-14 and 4-15. A significant amount of variation was observed in coupons processed at 500°F.

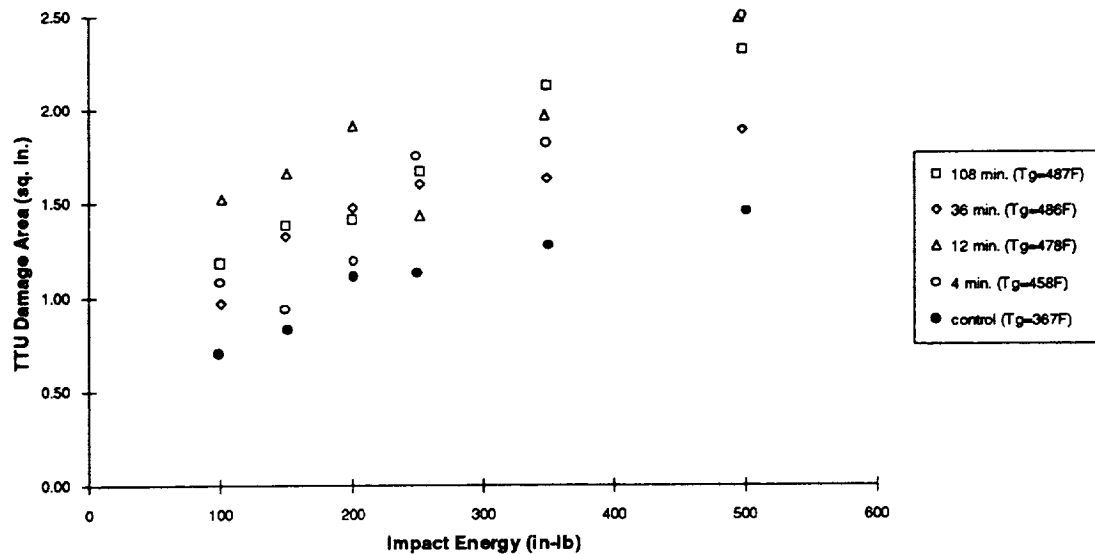
Figure 4-15. Impact Damage Resistance of Hexcel's HRP Honeycomb Following Exposure to 500°F.

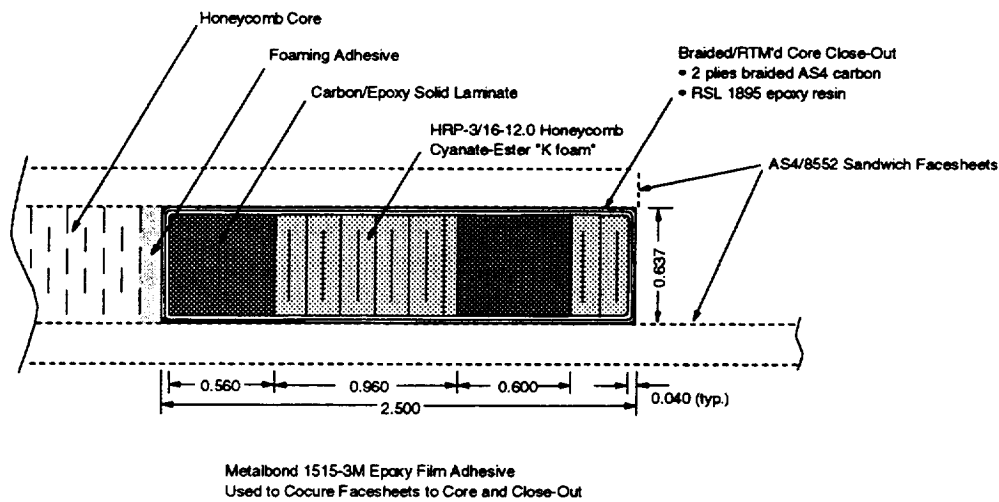
Figure 4-18. Longitudinal Panel Splice Core Close-out Constructed of a Braided/RTM'd Carbon/Epoxy Tube with Solid Carbon/Epoxy Laminate and Foam Filled Honeycomb Core.

A second design concept (Figure 4-18) consisted of a single braided and resin transfer molded carbon/epoxy tube with a core consisting of solid carbon/epoxy laminate and foam filled honeycomb strips. The solid laminate strips are located along fastener lines to react clamp-up loads. The assembled core serves as a braiding mandrel and fly away resin transfer molding tool. Hexcel's cyanate-ester K foam was used to fill the honeycomb for manufacturing demonstration articles. The K foam proved inadequate to resist RTM mold pressures and became infiltrated with resin. A more robust foam, such as that described below for window cutout core close-outs, would be required to pursue this concept further.

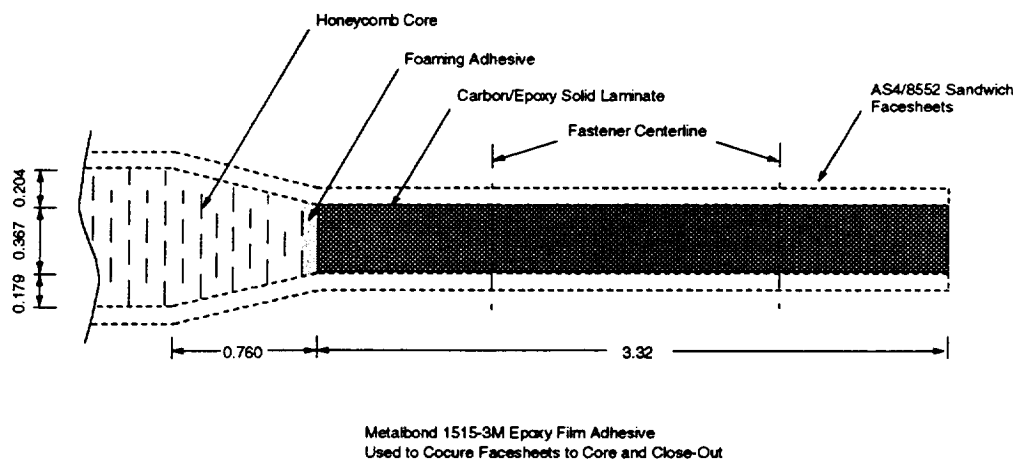
Figure 4-23. Circumferential Panel Splice Core Close-Out.

Only full depth core close-out concepts were pursued for circumferential panel splices. All of the concepts exhibited small chamfers on each side of the panel to accommodate splice plates, as illustrated in Figure 4-23. The primary difference between various concepts lay in whether the honeycomb extended through the chamfered area or was replaced by solid laminate in this area. Minor differences in close-outs manufactured for keel and side panels were in the type of core material and in the depth of the core chamfer. A cross-section of a core close-out in a circumferential splice test panel is presented in Figure 4-24.

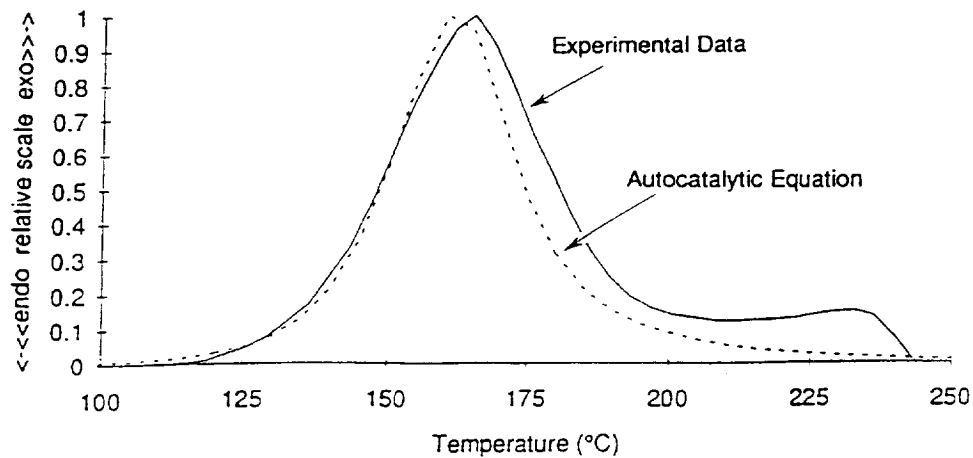
Figure 4-33. Comparison of Reaction Rate Kinetics of the 8552 Resin System with the Prediction of an Auto Catalytic Model.

A combined empirical and analytical approach was taken in development of a process for cocuring thick laminate/sandwich structure [9]. The reaction rate kinetics and rheology of 8552 epoxy were characterized. Results of dynamic differential scanning calorimetry (DSC) were used to confirm the ability to predict the reaction rate of the system. An auto catalytic kinetic model of the primary reaction adequately represents the data during the initial portion of the exotherm, as shown in Figure 4-33. The prediction diverges from experimental data as a second exothermic process begins at higher temperatures. Further refinement of the kinetic model to account for the second reaction were not pursued because the reaction progresses at a very slow rate at the cure temperature.

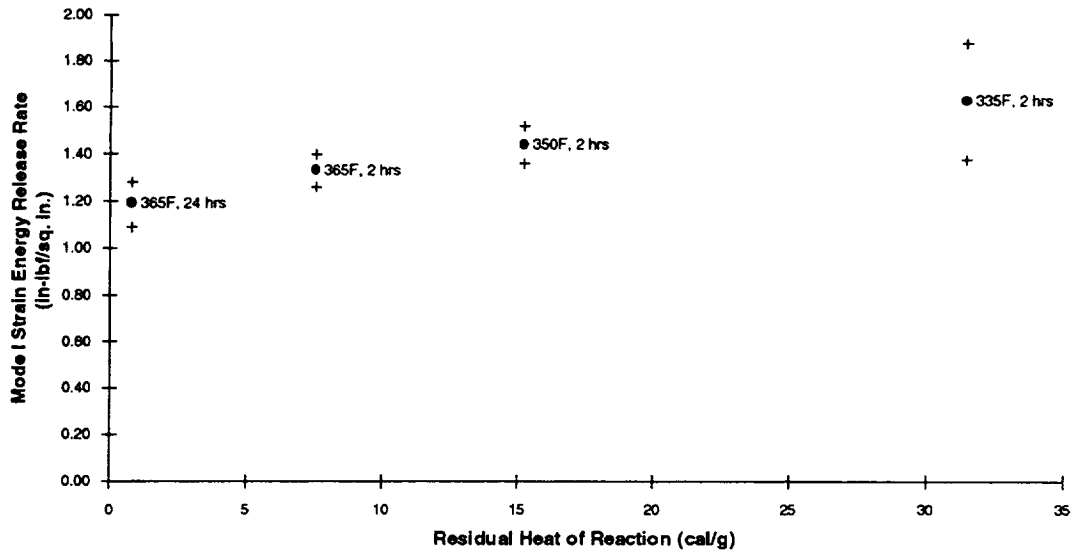
Figure 4-34. AS4/8552 Mode I Strain Energy Release Rate as a Function of Residual Heat of Reaction for Various Cure Cycles.

The influence of cure cycle variations and extended time at cure temperatures on the performance of 8552 composites were evaluated by measurement of in-plane lamina shear modulus and modes I and II interlaminar fracture toughness. Mode I fracture toughness exhibited the greatest sensitivity to variations in the cure cycle. Mode I fracture toughness decreased by 14% from nominal under the most severe cure cycle tested (24 hours at 365°F), but is expected to vary by only 5% in a typical production environment. A good correlation of fracture toughness with residual heat of reaction for various cure cycles (Figure 4-34) indicates a path independent relationship between level of cure and mechanical performance.

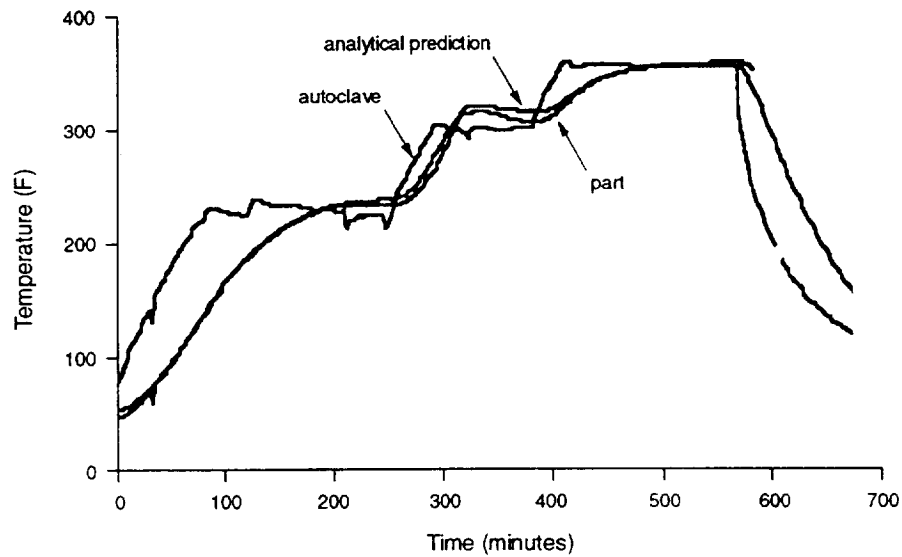
Figure 4-36. Comparison of Analytical and Experimental Results for the Thermal Response of the Process Trial Panel.

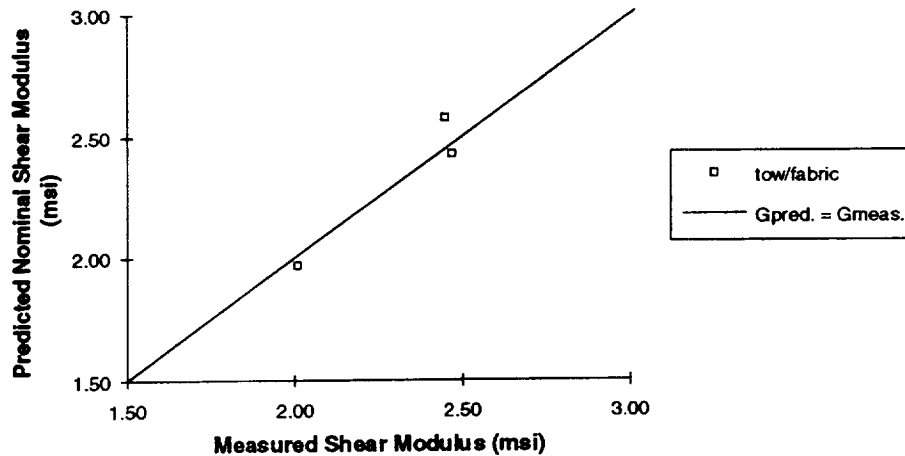
Figure 5-3. Predicted and Measured Shear Moduli of AS4/8552 Laminates.

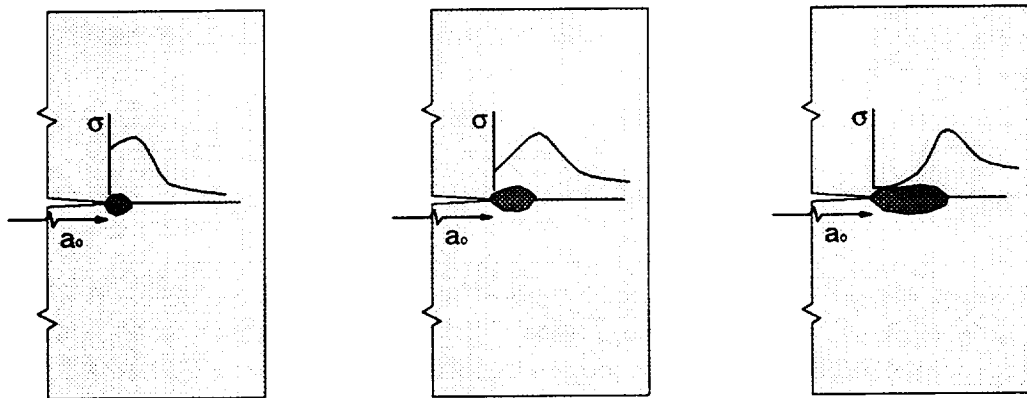
Figure 5-15. Modeling of Structural Collapse Due to Damage Growth.

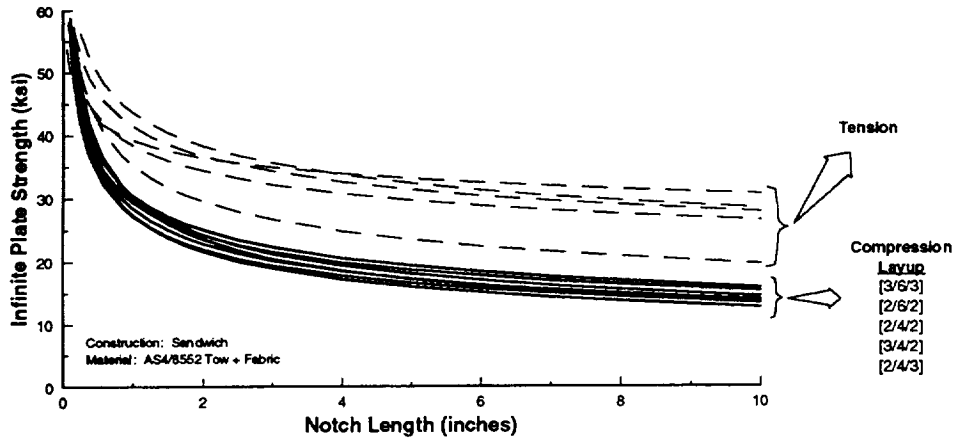
Figure 5-19. Comparison of Notched Tension and Compression Strengths ([X/Y/Z] indicates the number of plies in the $[0/\pm 45/90]$ orientations).

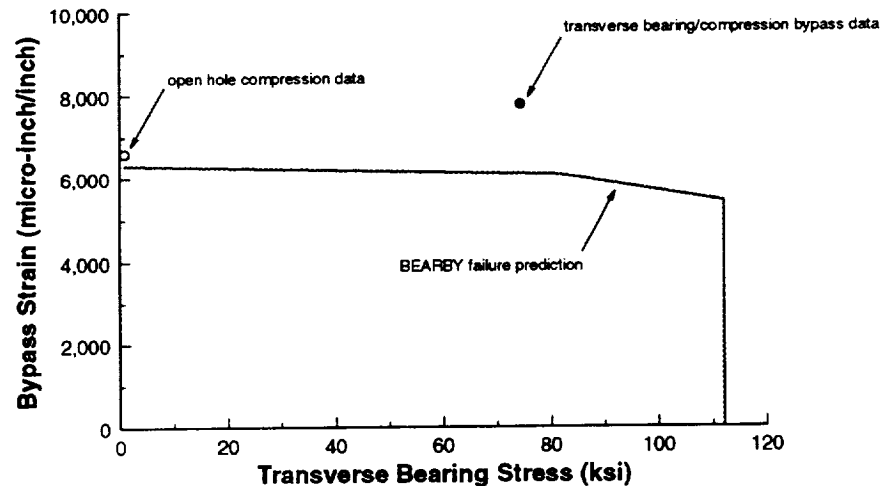
Figure 5-27. Prediction of Transverse-Bearing/Compression-Bypass Interaction with the BEARBY Analysis Code.

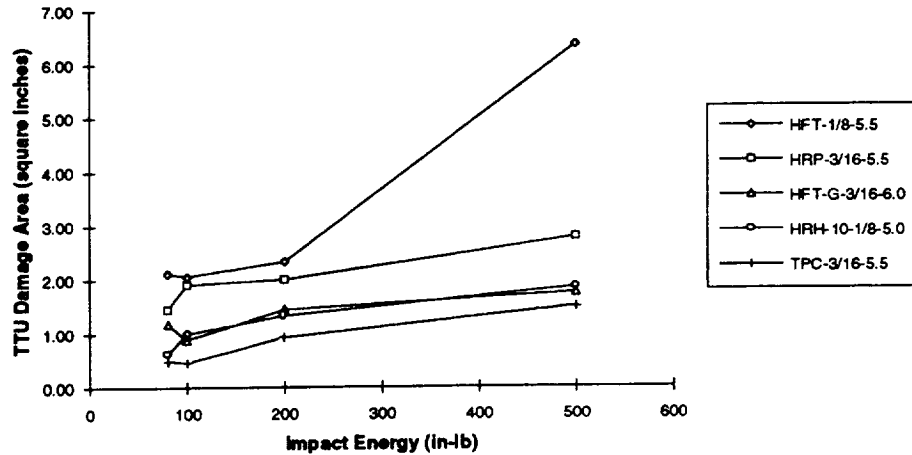
Figure 6-5. Impact Damage Resistance of Representative Minimum Gage Sandwich Structure with Candidate Honeycomb Core Materials.

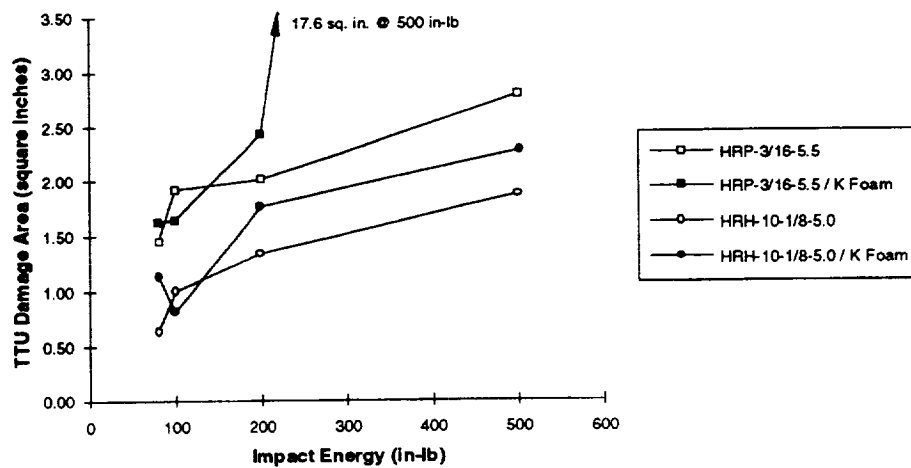
Figure 6-6. Impact Damage Resistance of Representative Minimum Gage Sandwich Structure with Foam-Filled Honeycomb Core Materials.

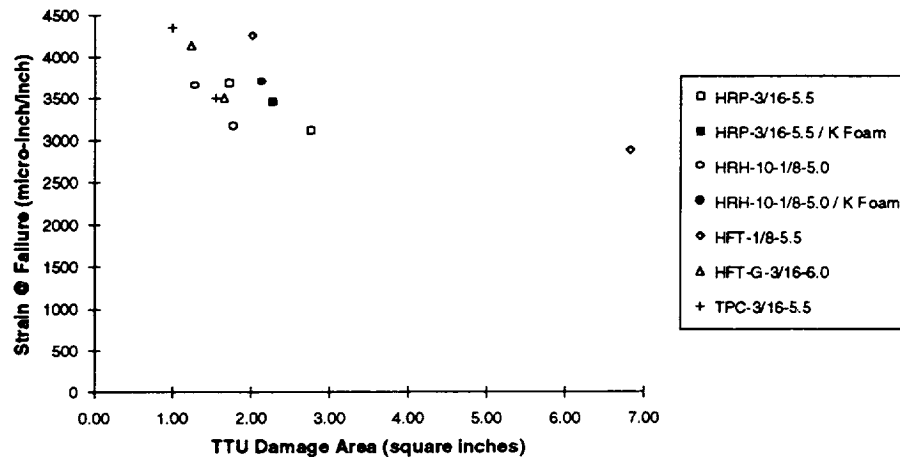
Figure 6-7. CAI Strength of Representative Minimum Gage Sandwich Panels with Candidate Honeycomb Core Materials.

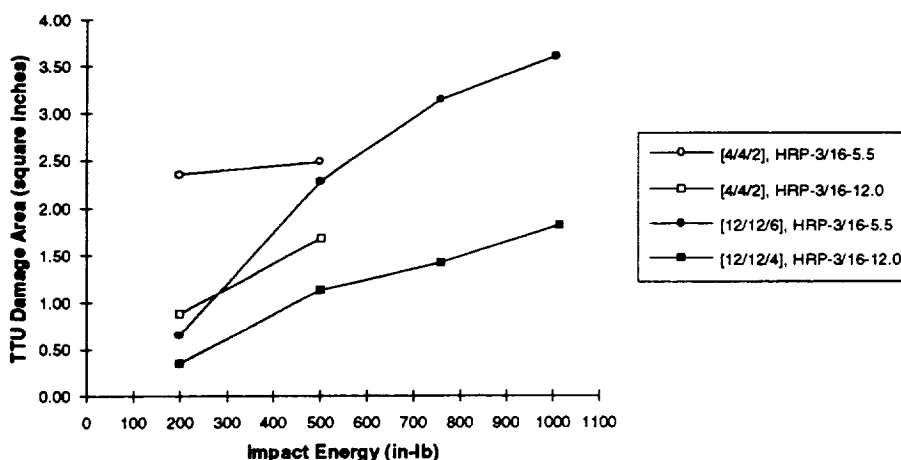
Figure 6-8. Influence of Facesheet Thickness on Impact Damage Resistance of Sandwich Structures.

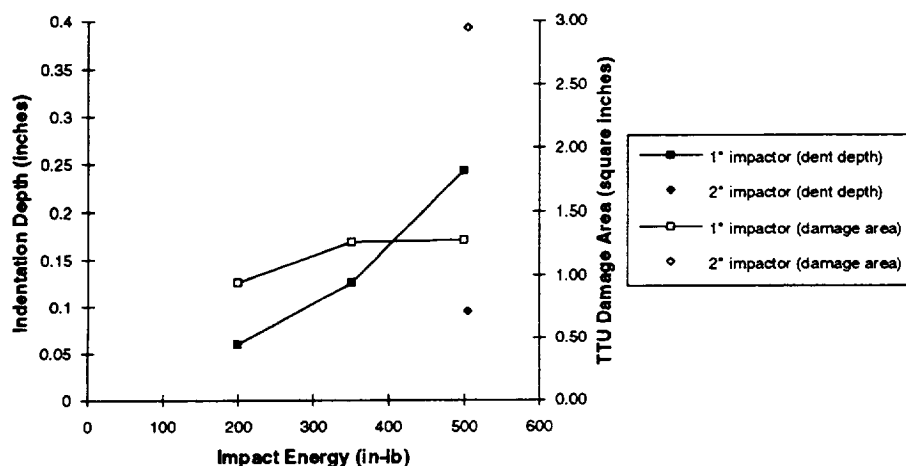
Figure 6-9. Impact Damage Resistance of Baseline Aft Keel Sandwich Structure.

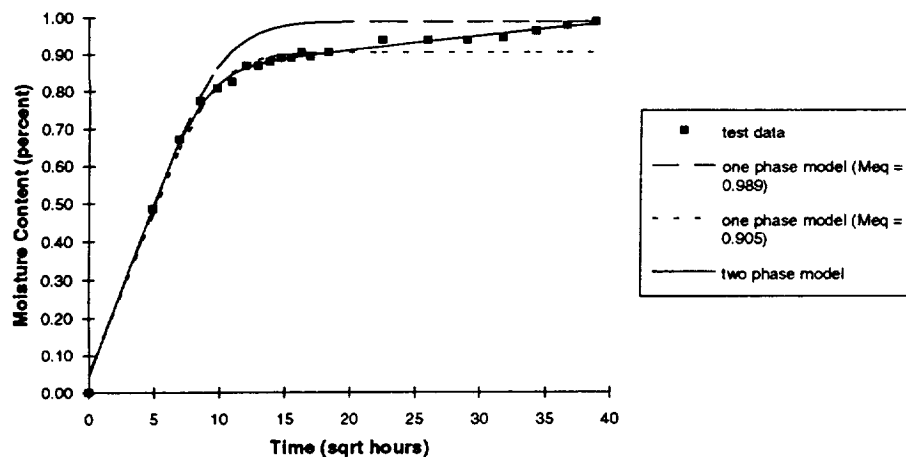
Figure 6-10. *Application of One and Two Phase Fickian Models to Diffusion of Water in AS4/8552 Tape (160F, 70% R.H.).*

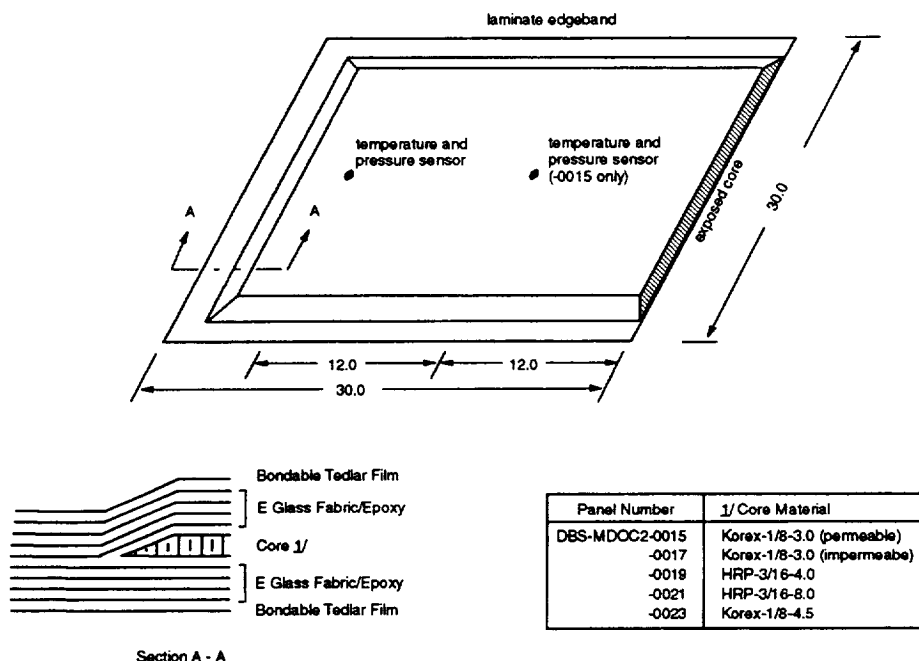
Figure 6-12. Sandwich Flight Cycle Test Panels.

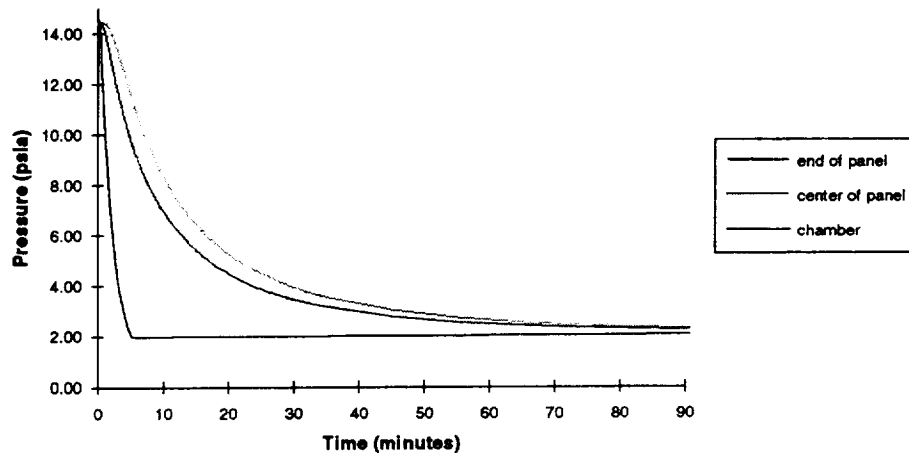
Figure 6-13. Internal Pressure Response of Flight Cycle Test Panel with Permeable Korex-1/8-3.0 Core to Reduced Pressure at Constant Temperature.

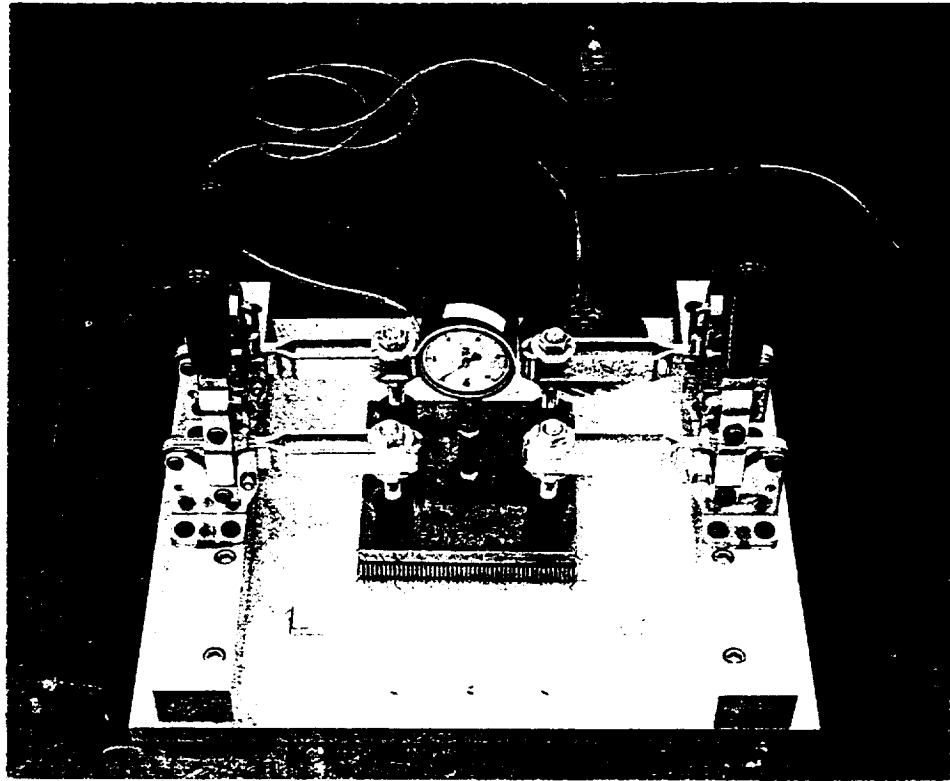
Figure 6-16. Sandwich Core Permeability Test Fixture Developed by Du Pont.

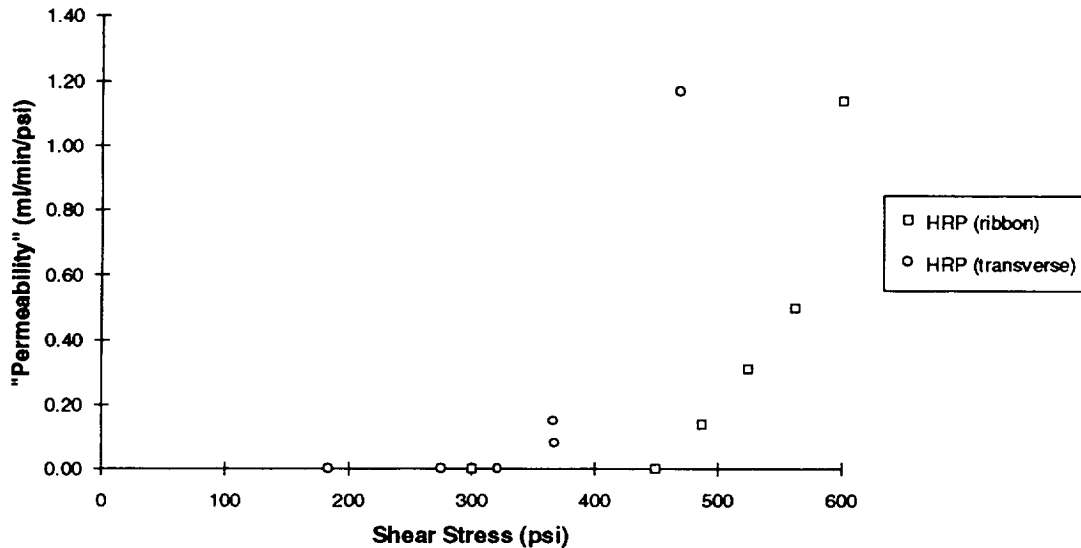
Figure 6-17 Air Permeability of HRP-3/16-8.0 Honeycomb Core Material Following Application of Static Shear Stress.

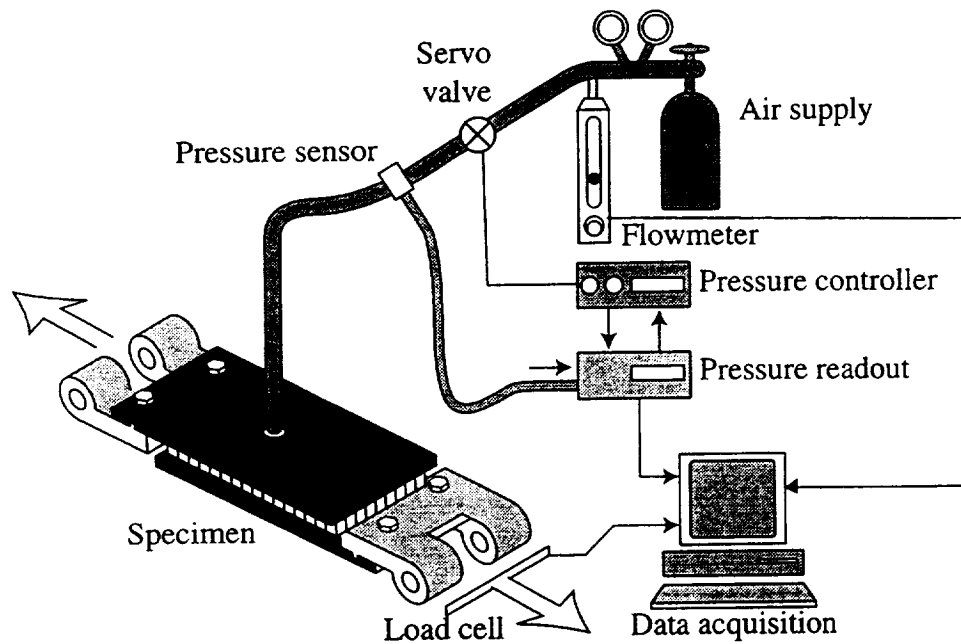
Figure 6-18. Schematic of Test Apparatus for Measuring Sandwich Core Air Permeability While Applying Static or Cyclic Shear Loads.

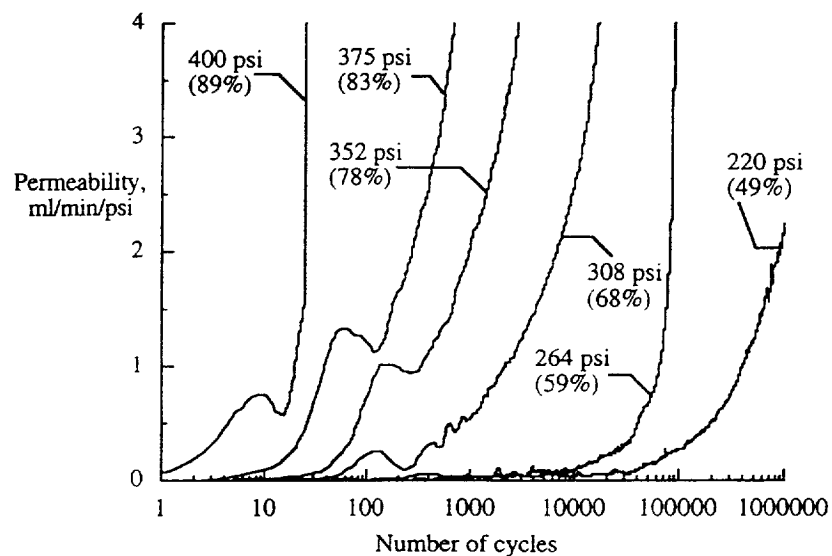
Figure 6-19. "Permeability" of HRP-3/16-8.0 Honeycomb Sandwich Core as a Function of Non-Reversed Cyclic Shear Stress.

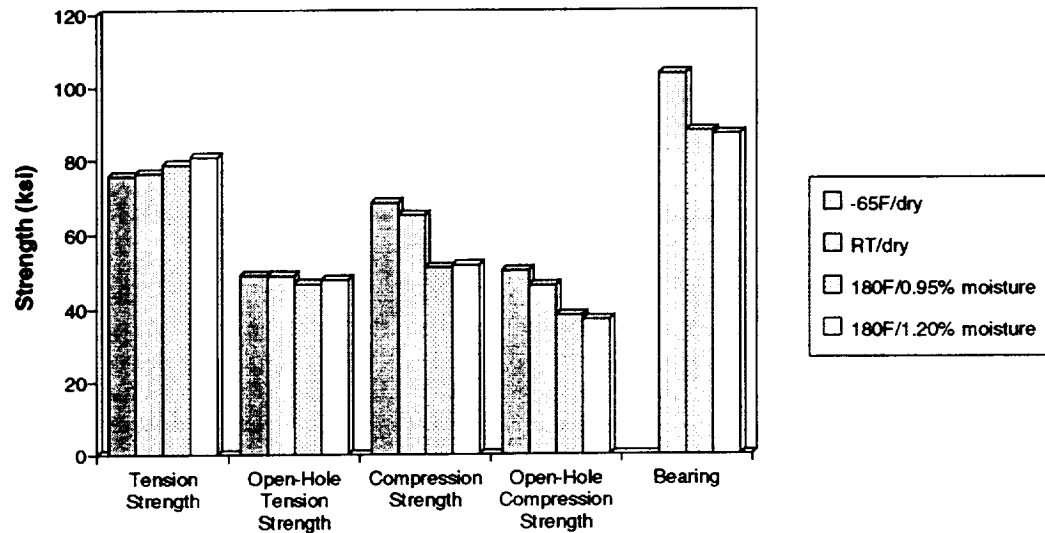
Figure 6-21. Influence of Absorbed Moisture and Elevated Temperature on the Mechanical Performance of AS4/8552.

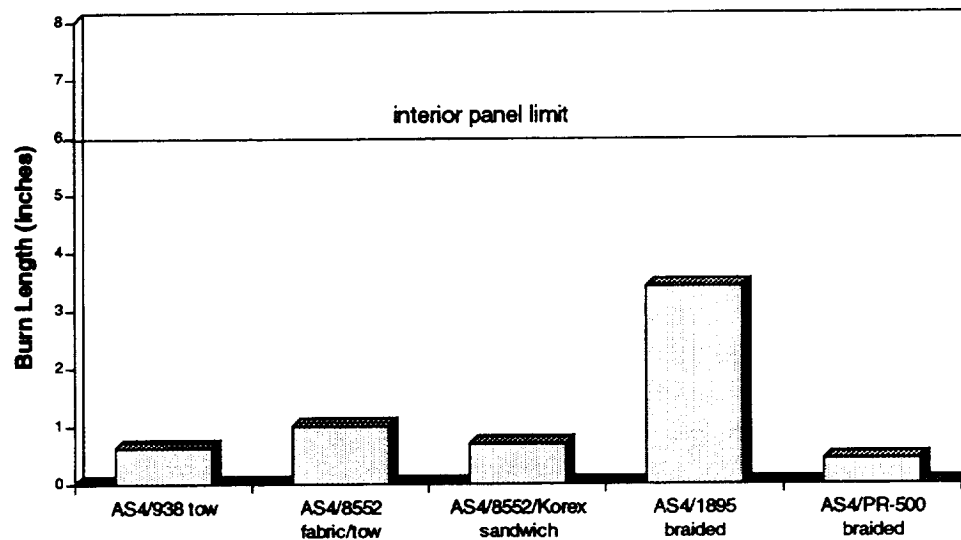
Figure 7-1. Results of Sixty Second Vertical Flammability Tests (Burn Length).

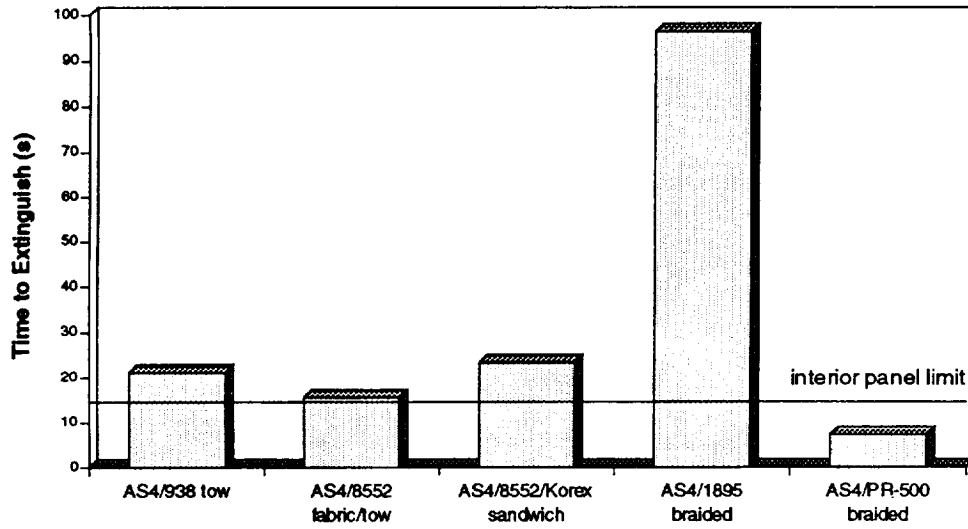
Figure 7-2. Results of Sixty Second Vertical Flammability Tests (Time to Extinguish).

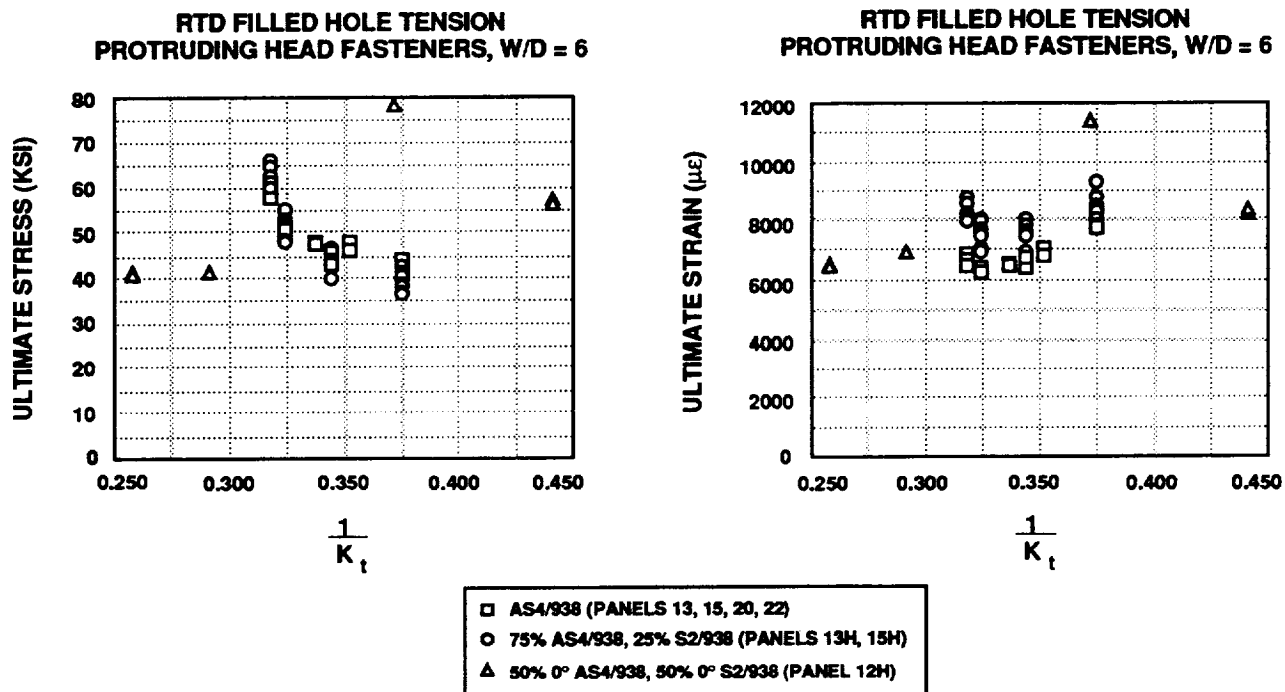
Figure C-13: Relationship Between Failure Stress and Strain and Stress Concentration Factor for AS4/938 and Hybrid Laminates
